ARMY AVIATION TEST BOARD FORT RUCKER ALA  
MILITARY POTENTIAL TEST OF NU-8F AIRPLANE. (U)  
OCT 64

FINAL  
REPORT OF  
MILITARY POTENTIAL TEST OF  
NU-8F AIRPLANE

DA PROJECT NO. 1X141809D179

USATECOM PROJECT NO. 4-4-1005-01

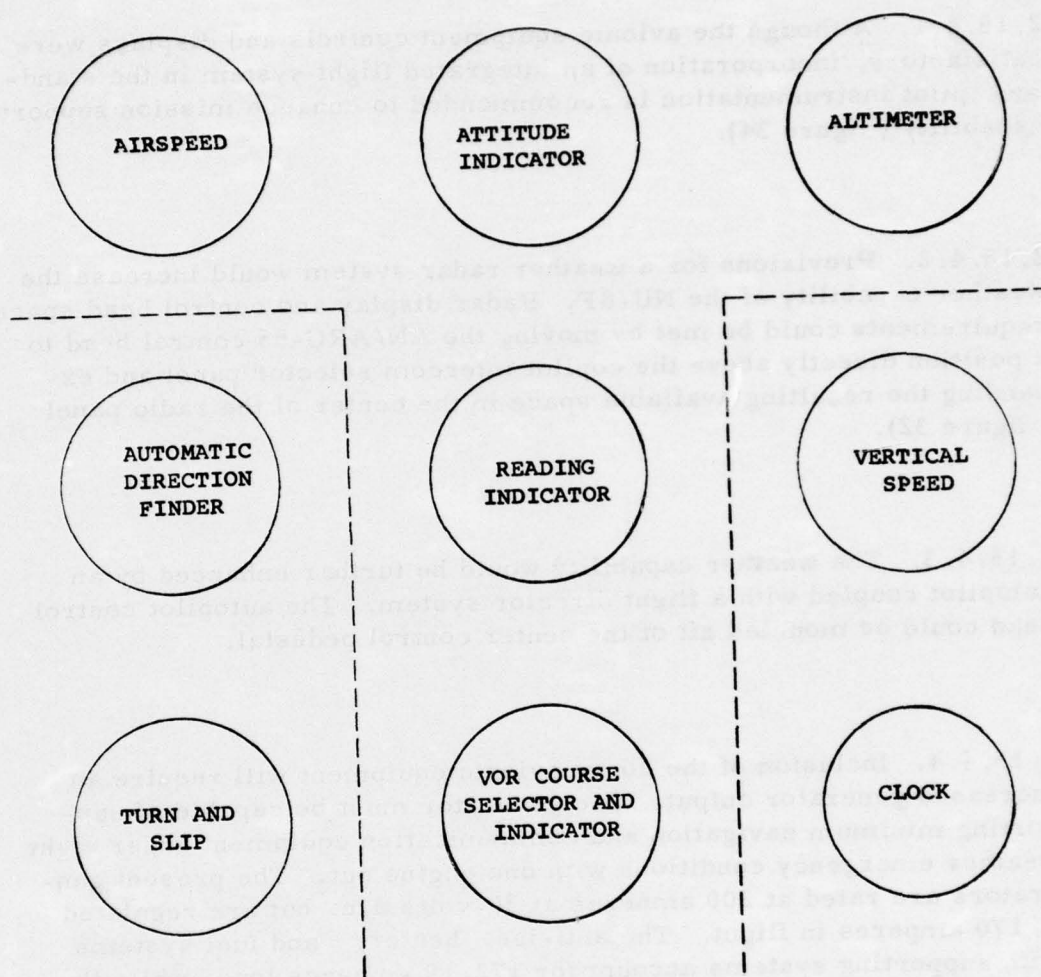
Figure 33

2.1.3.3.6. The pilot's flight instruments were not arranged in accordance with the Army standard "T" panel (figure 33).

2.15.3.2. Location and operation of avionic equipment controls and displays were satisfactory except that the pilot's instrument panel did not conform to the Army standard "T" panel configuration. (See figure 32 for NU-8F panel arrangement and figure 33 for standard "T" panel.)
